DME

BULLETINS: SERVICE AND TECHNICAL
PARTS, WARRANTY, ORGANIZATION.

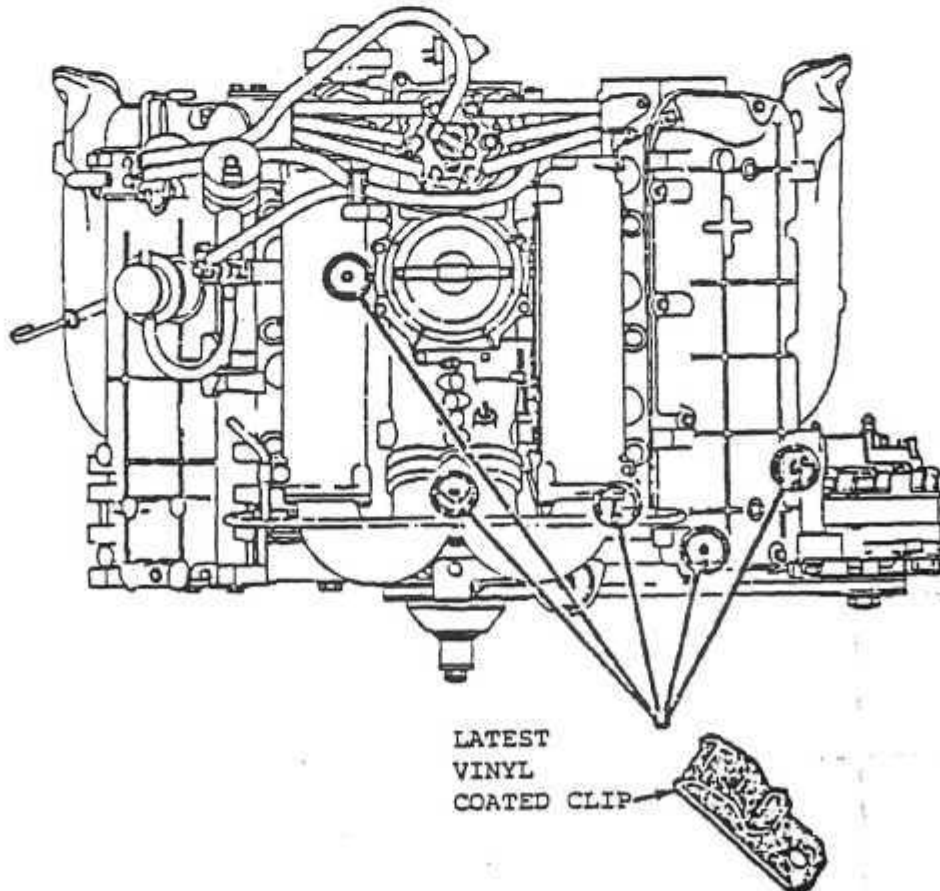
Vehicles found in service with the earlier type clips should be reworked using the latest vinyl coated type clips. The latest clips were introduced intermediately in production from VIN 1201.

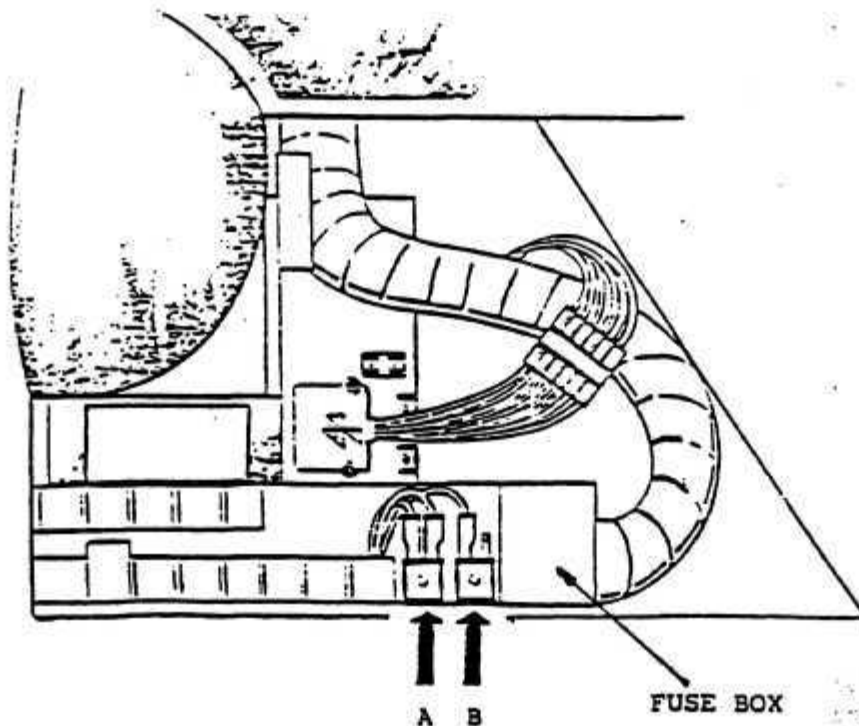
Check to ensure that the cooling fan circuit breakers are in the position as shown (Position A). Check to ensure that the blower fan circuit breaker is in the position as shown (Position B).

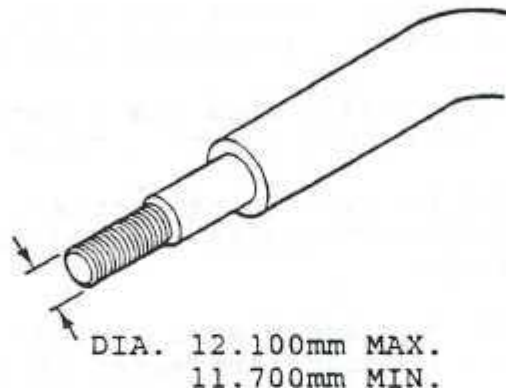
FIGURE 1

NOTE: If the reading is below 11.7 mm (.460 inch) replace the stabilizer bar with new unit (P/N 100233).
