DME

BULLETINS: SERVICE AND TECHNICAL
PARTS, WARRANTY, ORGANIZATION.

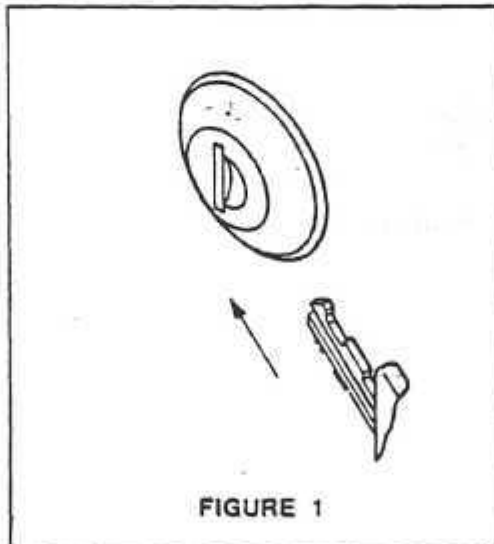
In order to properly insert the door key into the door lock's key slot, the slide plate, covering the key slot, must first be pushed aside with the key. This is best done by placing the tip of the key at an angle into the "crescent-shaped" recess, sliding the cover plate aside with the tip of the key and then inserting the key (Figure 1).

New vehicle owners should be informed of this technique when their vehicle is being delivered.

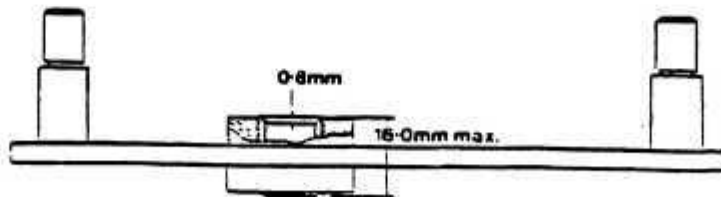
In the event of stiff gearshift action, carry out the following checks:

1. Raise vehicle and release both gear linkage control rods from bell crank through access opening on underside of frame.
2. Check that the bell crank pivots freely. If not, release pivot bolt and remove bell crank.
3. Check that upper end of the bell crank pivot bush has a 0.8mm deep 45° chamfer to accommodate bolt head radius.
4. Check that the pivot bush's total length does not exceed 16.0mm.
5. If necessary modify the bush to obtain conditions as specified under 3 and 4.
6. Lubricate all pivot points with multi-purpose lithium based grease, and refit bell crank and pivot bolt with two 8mm washers (SP10032) between bell crank and frame brace. Torque pivot bolt to 22Nm (16 ft. lb.) and check that the bell crank pivots freely. Refit gearshift control rods.

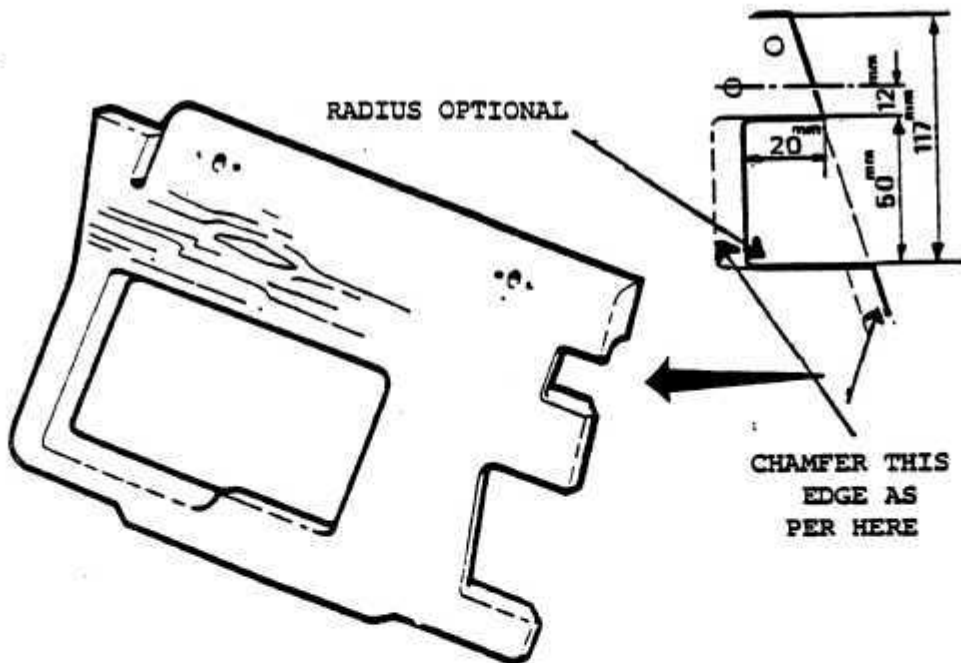
From V.I.N. 2309, a recess has been cut out of the right rear bulkhead panel to accommodate the wiring harness. See the diagram below.

This modification may also be made on earlier vehicles to improve harness routing.

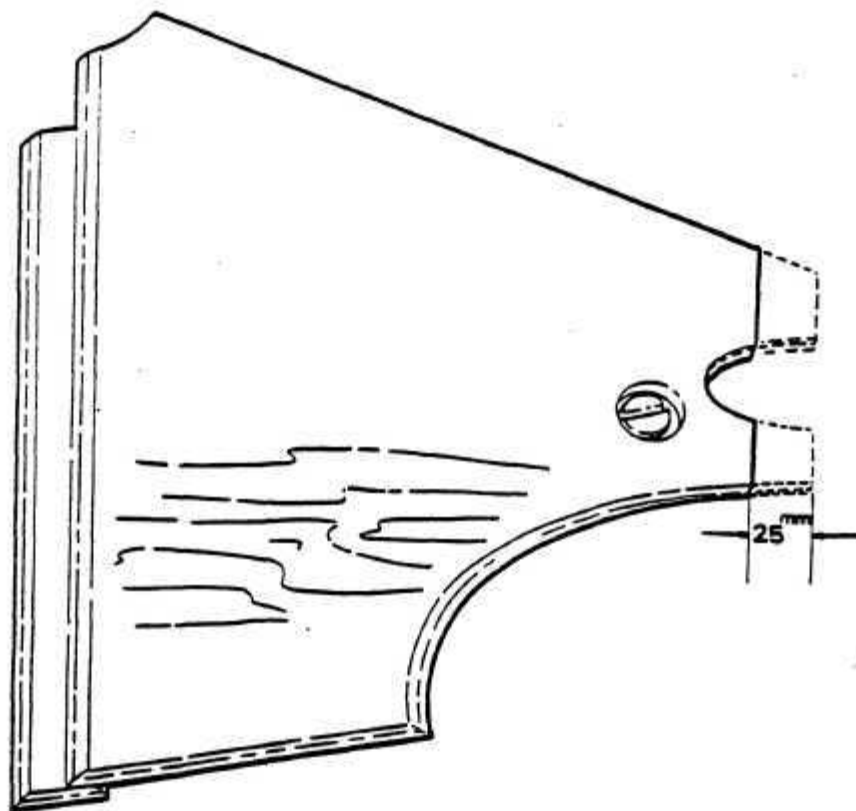
From V.I.N. 2309, to facilitate removal of the rear parcel shelf boards, 25mm has been cut from the top edge of both boards. See the diagram below.

This modification may also be made on earlier vehicles.

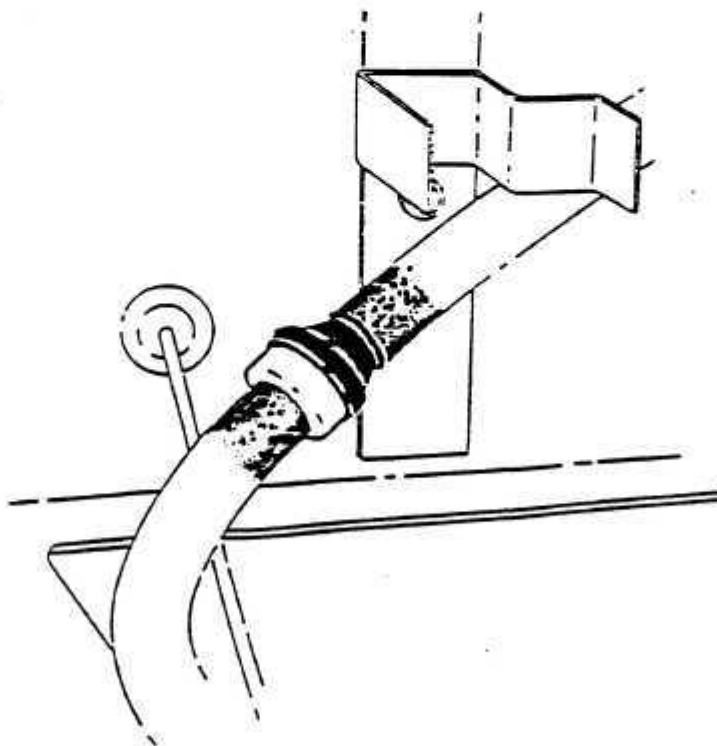
The black and white plastic valve is fitted into the vacuum line between the vacuum reservoir and engine and is to be found towards the left front of the engine compartment.

When correctly fitted, the black side of the valve faces towards the engine.

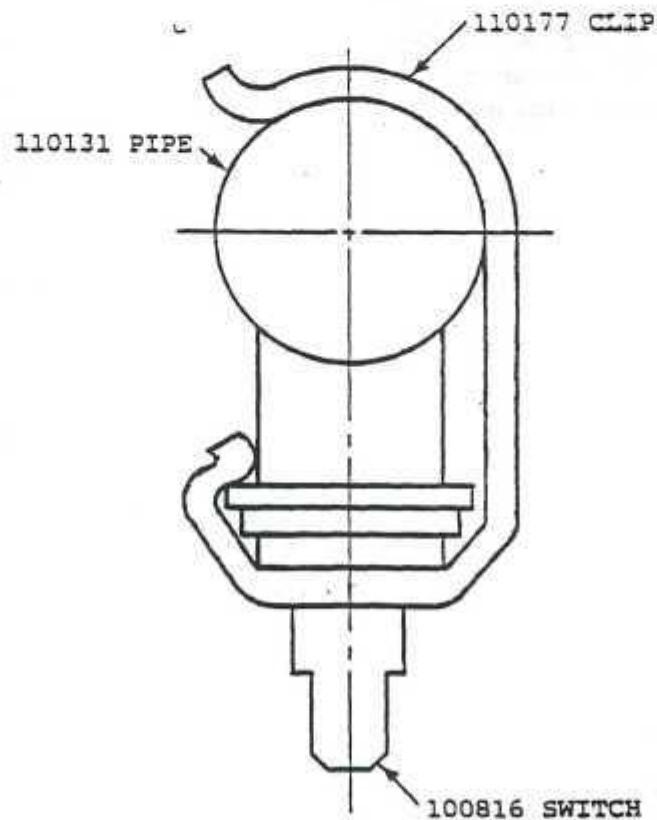
This clip is not interchangeable and will only fit water pipe Assembly No. 110131.

Factory introduction with V.I.N. 3850.

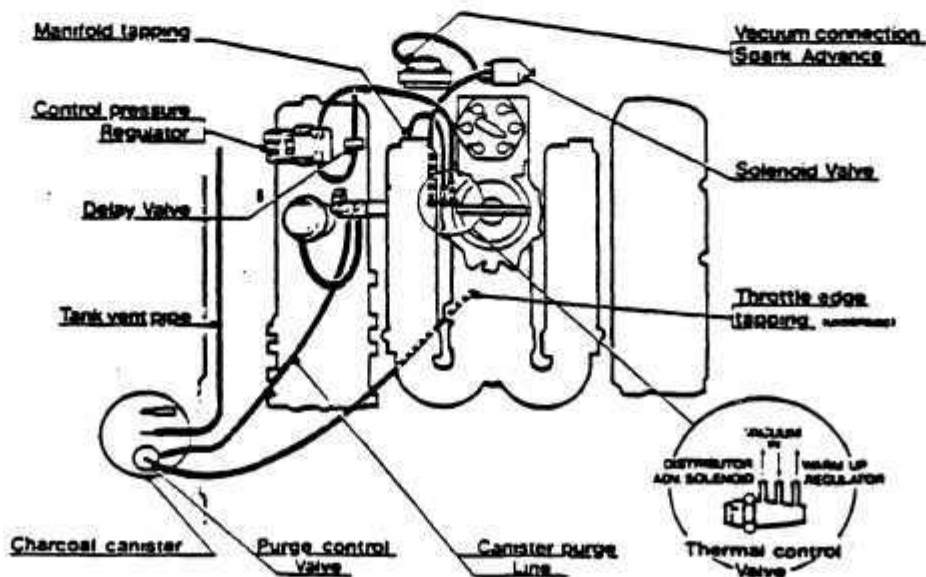
Explanation: When the engine is cold, the thermal control valve directs vacuum to the control pressure regulator. After the engine is warmed up, the thermal control valve then shuts off vacuum to the control pressure regulator and directs vacuum to the distributor advance solenoid.

To Check: For proper hose routing at the valve, check to see if vacuum is present at the control pressure regulator upon cold initial start-up at idle. Then, after vehicle warms up, check to see if vacuum exists at the distributor advance solenoid.

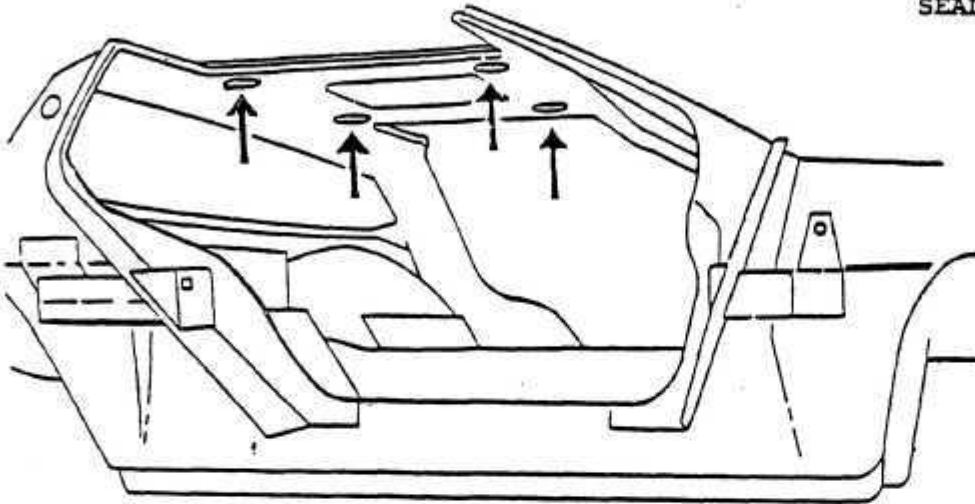
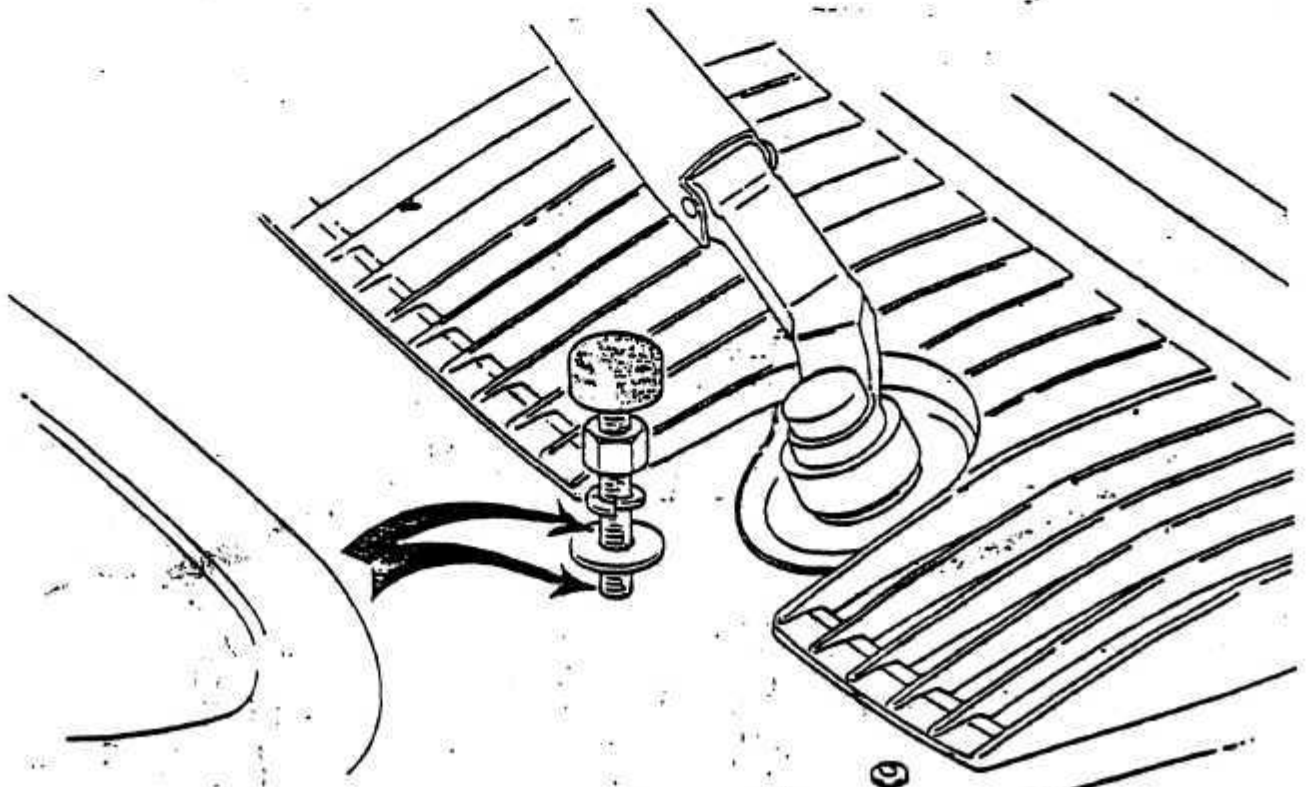
FOUR OFF BIG HEAD BOLTS
IN ROOF AREA SEALED AS
SHOWN WITH DOW SILASTIC RTV
SEALANT.

HOOD BUMP STOPS :
1. SCREW TOP NUT, LIFT WASHER & APPLY BLACK SILASTIC
SEALANT ABOVE AND BELOW THE WASHER. RETIGHTEN THE
TOP NUT. WIPE OFF EXCESS SEALANT.
THE ADJUSTMENT OF THE BUMP STOP MUST NOT BE UPSET,
AS THE BOTTOM NUT IS LOCATED ON

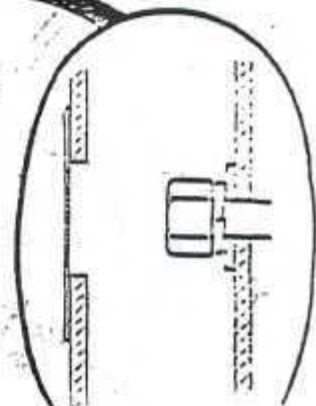
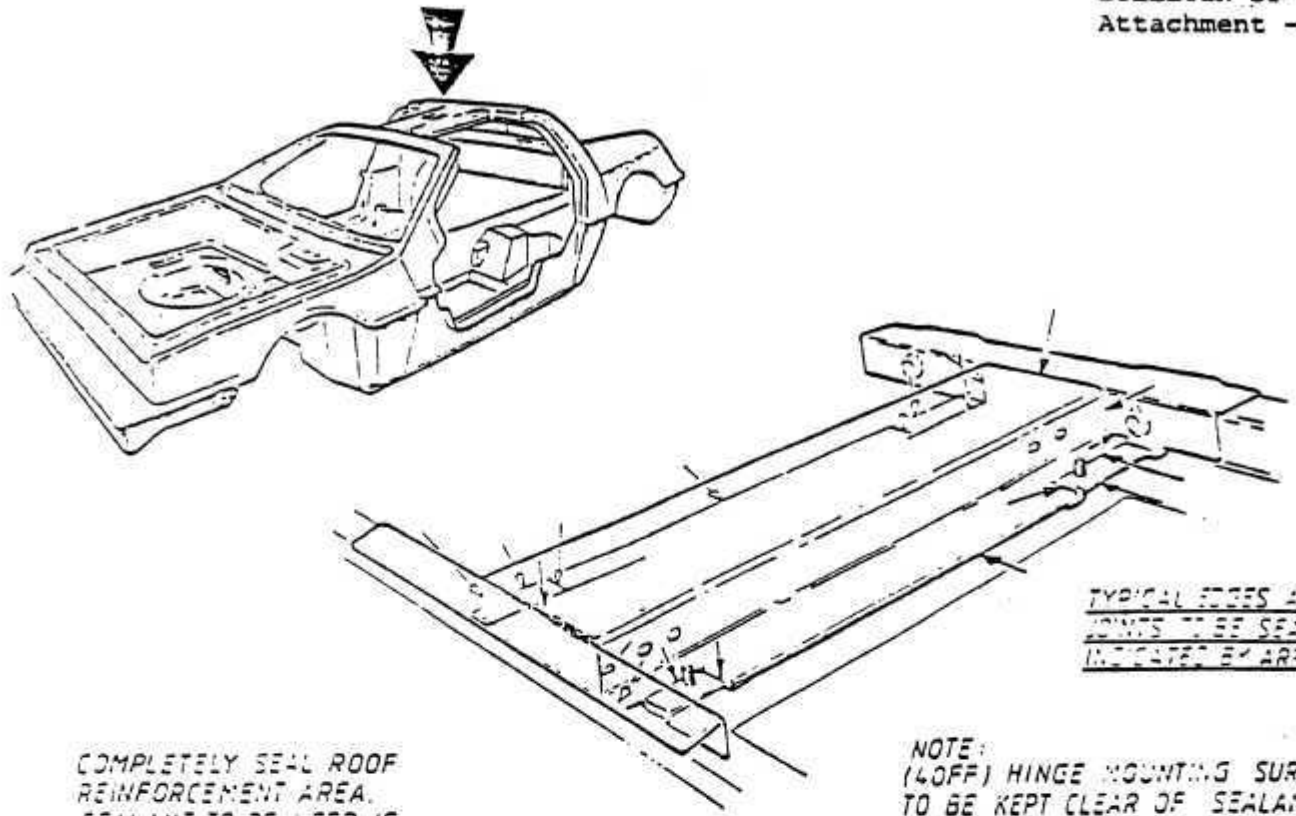
TYPICAL EDGES AND JOINTS TO BE SEALED INDICATED BY ARROWS

COMPLETELY SEAL ROOF REINFORCEMENT AREA. SEALANT TO BE USED IS PTV 732 SILASTIC. SEALANT BEAD TO BE 'WIPED' INTO JOINT AFTER APPLICATION.

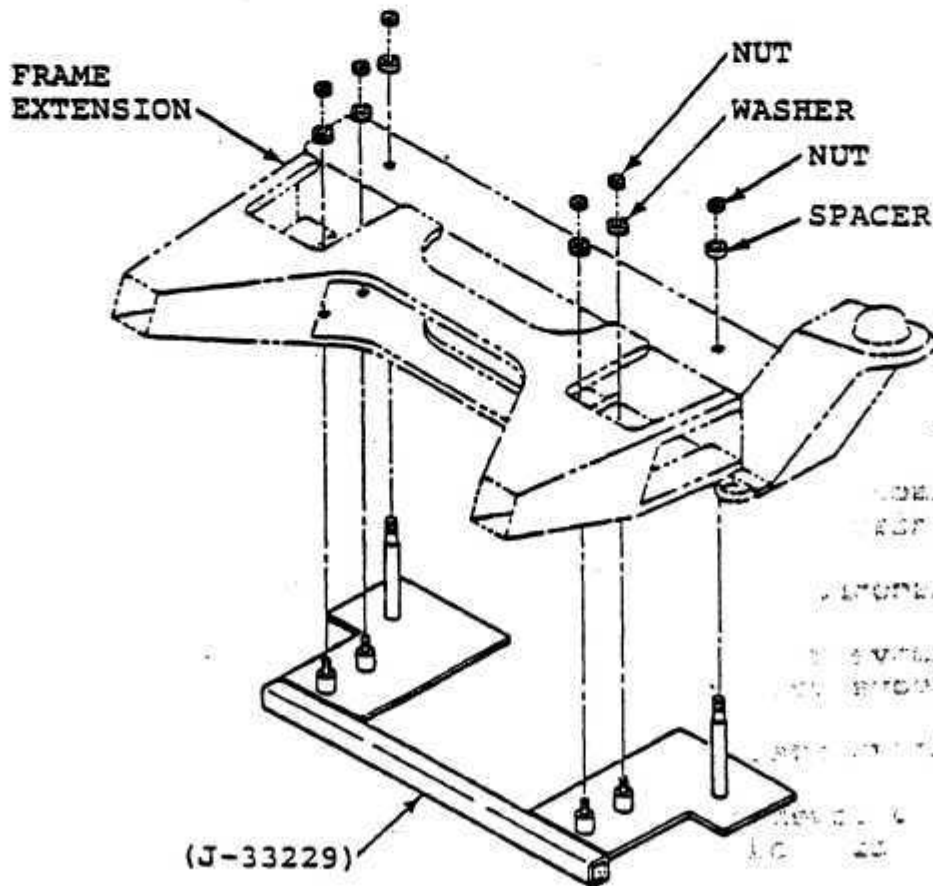
FIGURE 1

In the event that the front frame extension of a DeLorean is damaged in an accident the following repair procedure has been established:

17. Attach alignment jig J-33229 loosely to front cross member (See Figure 1).

18. Attach new front frame extension (Part No. 105289) to alignment jig J-33229 (See Fig. 1). Tighten all fasteners on alignment jig while simultaneously checking positioning of frame extension to cross member.
19. Tack weld at all major contact points and remove jig. Continue welding until all contact areas are joined. Allow to cool.
20. Clean all bare metal surfaces and coat with corrosion protective kit Part No. 109264/5. Allow to dry.
21. Reinstall all parts in reverse order. Replace section removed from spare wheel well using a suitable fiberglass repair kit.

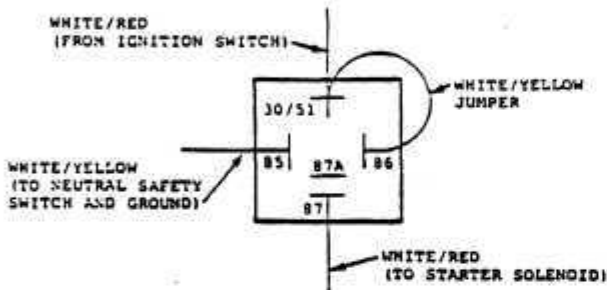
FIGURE 1

On early vehicles (prior to V.I.N. 2547), the starter solenoid's operating voltage, in certain conditions, was not high enough to ensure a consistent, reliable operation. This condition was displayed by a voltage drop characteristic in the main wiring harness on vehicles with slightly discharged batteries. To correct this condition a starter circuit modification was introduced into production starting at V.I.N. 2548.

BEFORE MODIFICATION

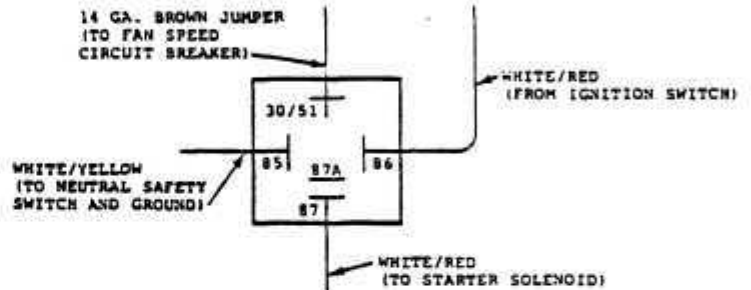
FIGURE 2

AFTER MODIFICATION

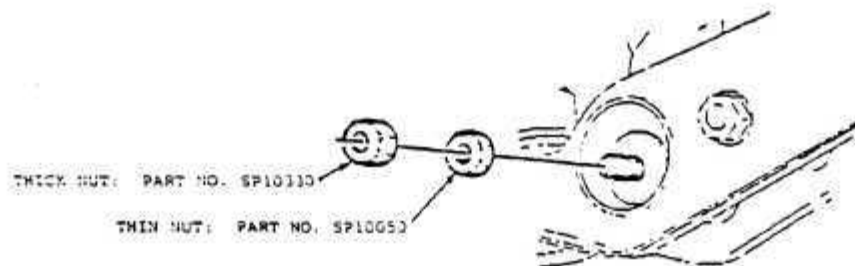
Attached to this bulletin are the alignment checking and setting procedures for De Lorean front and rear suspensions.

STABILIZER BAR TO LOWER LINK MOUNTINGS

1. Remove existing nylock nut and discard.
2. Clean stabilizer bar threads.
3. Coat stabilizer bar threads with Stud-N-Bearing Mount Loctite or Stud-N-Bearing Mount Permatex. Install thin nut Part No. SP 10050 and torque to 60NM (44 ft/lbs).
4. Recoat remainder of the thread with Stud-N-Bearing Mount Loctite or Stud-N-Bearing Mount Permatex and install thick nut Part No. SP 10330 and torque to 90NM (68 ft/lbs). When performing Step 4, ensure that the thin nut doesn't rotate.
5. With red paint, color code all areas of rework: top and bottom ball joints, right and left-hand front stabilizer bar mountings, rear stabilizer bar mountings.
6. Lower hoist to waist level, mount road wheels and torque to specification 80NM (59 ft/lbs).
